Greater New Haven Water Pollution Control Authority

Wastewater Treatment System

Performance Evaluation Report

December 2011

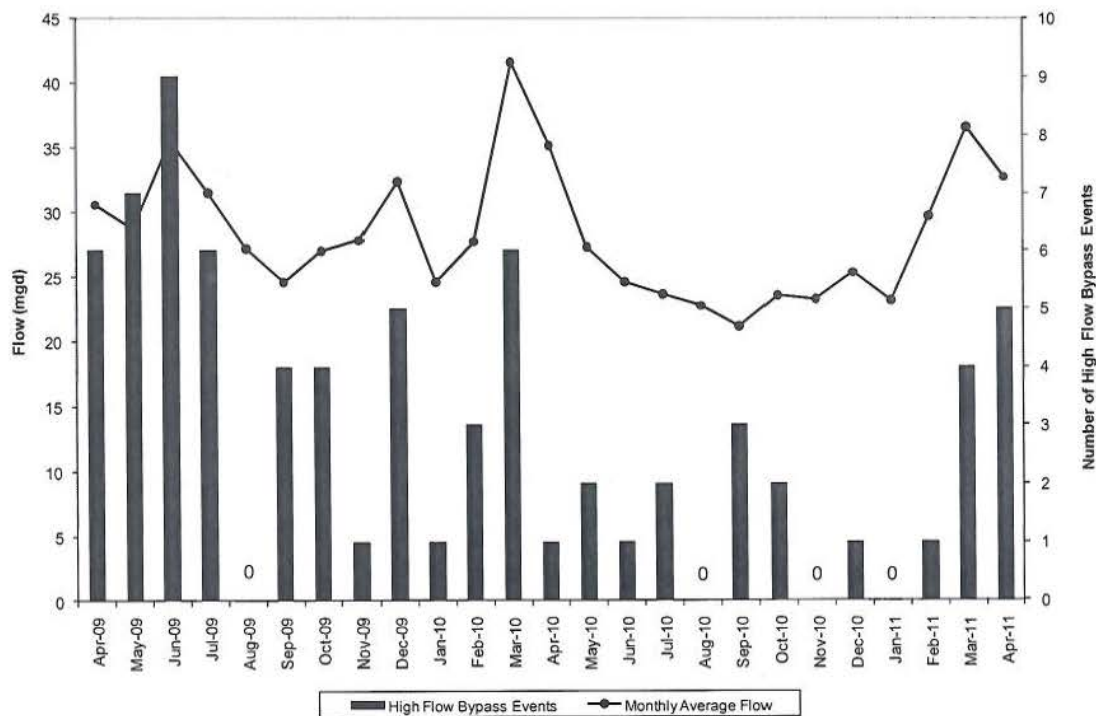
Figure 3-1: Wastewater Flow Characteristics¹

Wastewater flow characteristics are useful when evaluating other parameters, because flows often coincide with other observations. The number of high flow bypass events is included on this graph because these events can adversely affect the effluent quality.

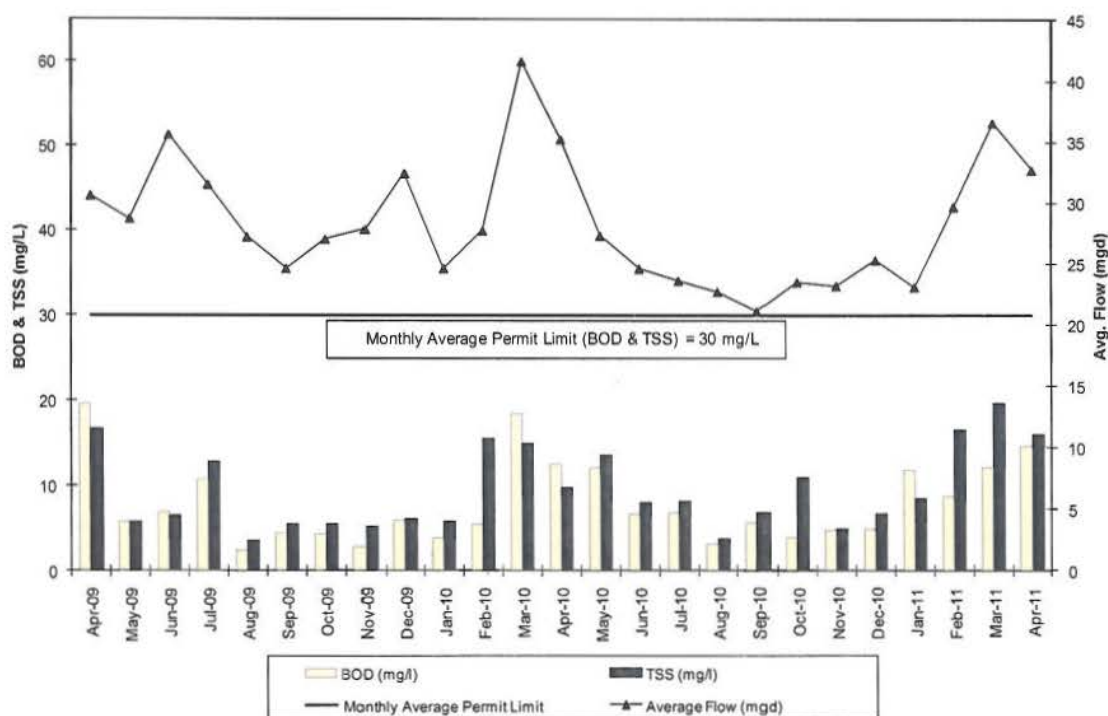
Figure 3-2: BOD and TSS Compliance¹

Agreement limits: 25 mg/l maximum monthly concentration; 20 mg/l average annual concentration based on a 12 month moving average.

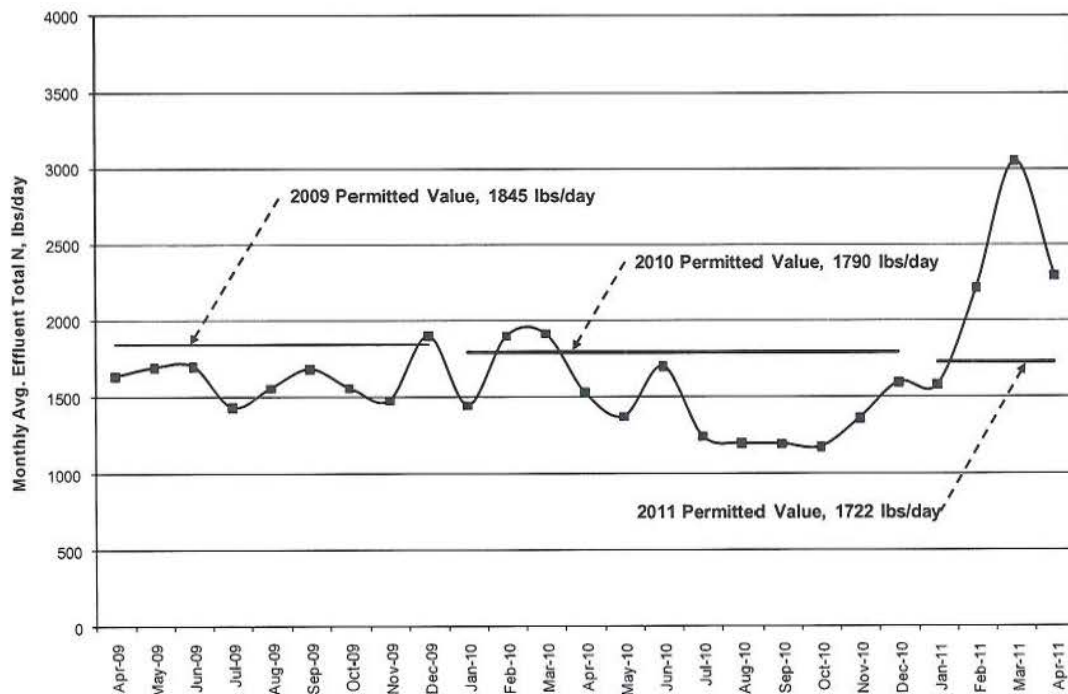
Figure 3-3: Monthly Average Effluent Total Nitrogen¹

The WPAF's monthly average effluent TN from April 2009 to April 2011 is shown in Figure 3-3. Overall compliance with TN requirements was very good, except in February and March of 2011. OMI reported that these spikes in effluent TN occurred during high flow conditions during an extreme winter. Under those conditions the nitrogen removal efficiency of the WPAF activated sludge/BNR process was severely reduced. It is worth noting that OMI's 2010 monthly average effluent TN (1467 lbs/day) was less than the future TN limit set for 2014 and 2015 (1568 lbs/day).

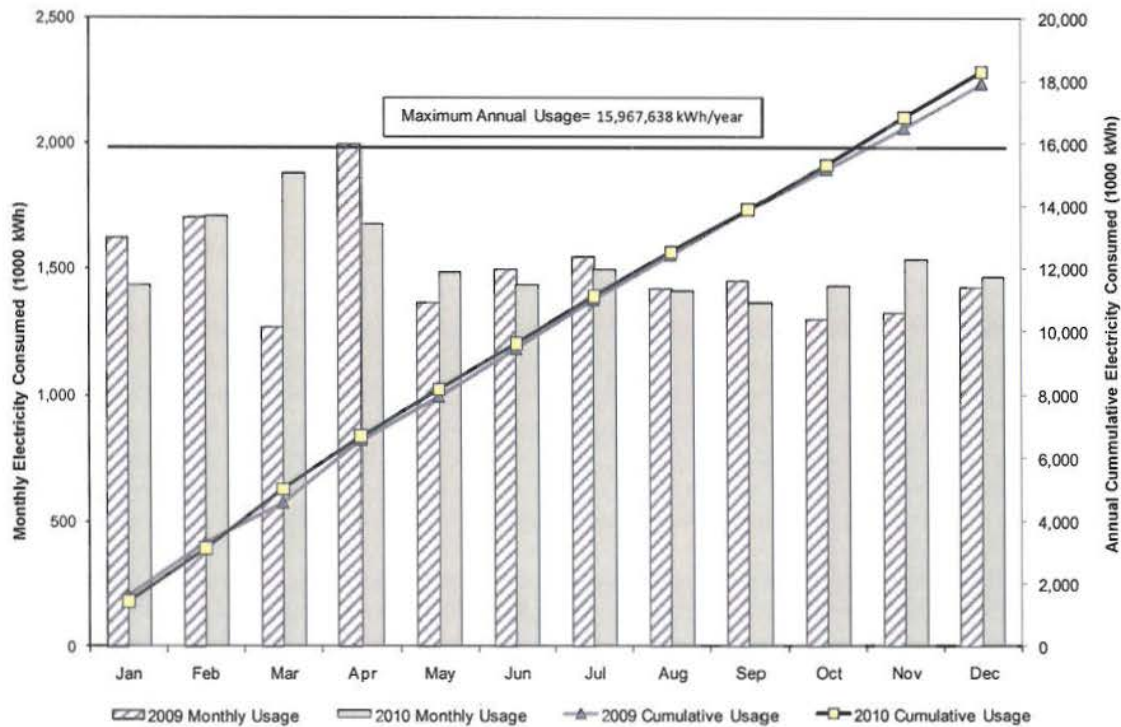
Figure 3-4: Monthly and Cumulative Annual Electric Consumption¹

Figure 3-4 indicates the total electrical consumption for the system for January 2009 - December 2010. Monthly consumption values are from the 2009 and 2010 Electricity Excess Usage Invoices issued to OMI by GNHWPCA (Yr. 2011 data was not yet available). OMI exceeded the adjusted total maximum electrical usage in 2009 by 1,950,158 kWh and in 2010 by 2,342,464 kWh.

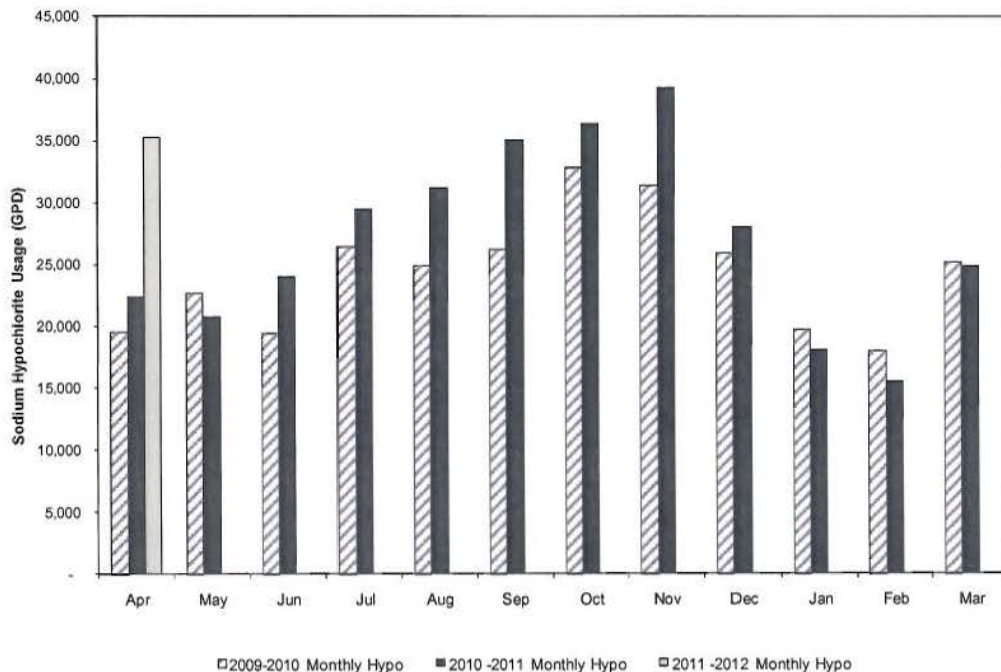
Figure 3-5: Monthly Sodium Hypochlorite (Hypo) Consumption¹

2009 and April 2010. The increase observed in the late summer and early fall months reflects increased chemical consumption by the inlet works RJ scrubber that is double or triple the amount consumed in other months. The sodium hypochlorite usage for disinfection is generally consistent throughout the year.

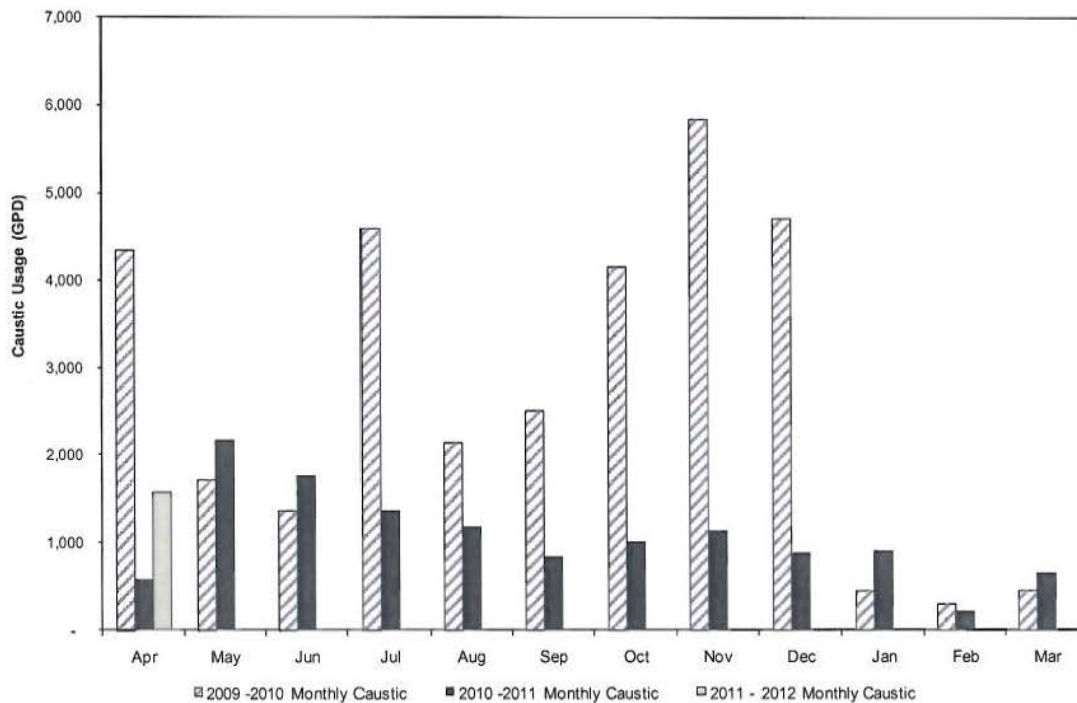
Figure 3-6: Monthly Sodium Hydroxide (Caustic) Consumption¹

As shown in the figure, the monthly consumption of caustic in 2009 was generally much higher than consumption in 2010. So far in 2011, caustic usage is trending relatively close to the amount used in 2010. According to OMI, the decreased use of caustic can be attributed to a greater reliance on sodium hypochlorite rather than caustic for wet scrubber odor control systems. OMI has determined that it is cost effective to use more sodium hypochlorite to reduce the amount of caustic required.

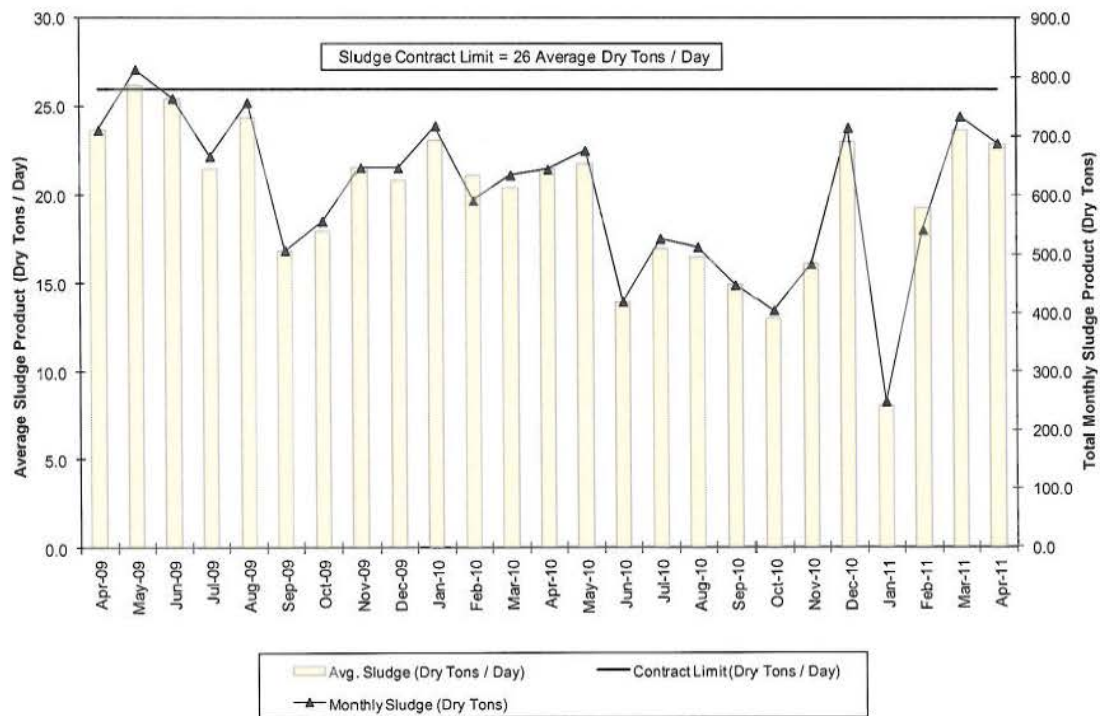
Figure 3-7: Monthly Sludge Production¹

Figure 3-7 indicates the dry sludge produced per month at the WPAF during the period of April 2009 through April 2011. These values were obtained from the OMI Monthly Solids Report for the East Shore WPAF.
